# Journal of Power Sources

# Investigations on degradation of the long-term proton exchange membrane water electrolysis stack

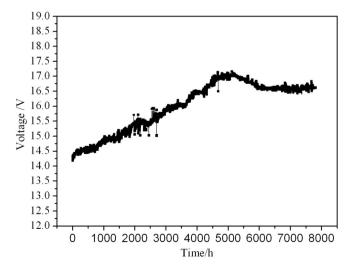
The experiments were performed to investigate the stability of a 9-cell PEM stack for 7800 h. The measured voltage of the stack varying with running time is shown in Fig. 2. According to Fig. 2, the voltage curve can be approximately divided into four regions. In first region of 0–4805 h, the voltage increases gradually from 14.16 V to maximum value 17.07 V, the fit curve illustrates the degradation rate is 0.589 mV h $^{-1}$ . In second region of 4805–5094 h, the voltage nearly keeps stable. Whereas, in third region of 5094–6075 h, the voltage dramatically decreases from 17.05 V to 16.55 V in the rate of 0.512 mV h $^{-1}$ , suggesting the enhanced cell performance. At last, the electrolysis voltage almost levels off (ca. 16.65 V). The average degradation rate of the individual cell voltage is around 35.5  $\mu$ V h $^{-1}$  during 7800 h life. In order to understand the observed degradation of stack performance, the 4th MEA was offline analyzed.

Fig. 2. Stack voltage varying with running time of water electrolysis during long-term operation.

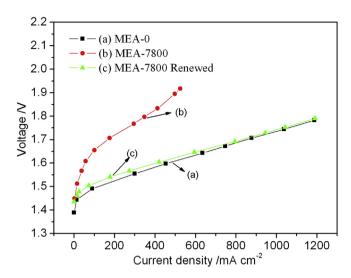
As can be seen from Fig. 3, I-V curves of MEA-0, MEA -7800 and MEA -7800 Renewed were investigated. The performance of MEA -7800 is obviously worse than that of MEA-0 and MEA -7800 Renewed, the voltage increases from initial 1.61 V-1.897 V at 0.5 A cm<sup>-2</sup> after 7800 h operation. After recovery treatment, MEA -7800 Renewed performs nearly as good as the fresh MEA in Fig. 3. The cell voltage recovers from 1.897 V to 1.624 V at 0.5 A cm<sup>-2</sup>, which almost attains 99.1% initial performance. The result displays that the performance deterioration is reversible after 7800 h operation and can be recovered by dilute sulfuric acid.

**Fig. 3.** Comparison of I-V curves for (a) MEA-0, (b) MEA-7800 and (c) MEA-7800 Renewed.

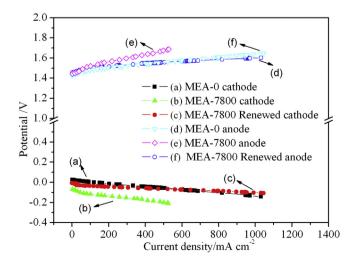
displayed in Fig. 4, the electrode potential of MEA-7800 is visibly worse than that of MEA-0 and MEA-7800 Renewed. The cathode potential of MEA-7800 decreased from -0.06 V to -0.2 V in the range of  $0-530 \text{ mA} \text{ cm}^{-2}$ , and its anode potential increased from 1.44 V to 1.68 V in Fig. 4(b and e). However, the anode and cathode potentials of MEA-0 and MEA-7800 Renewed were almost uniform in the range of  $0-1000 \text{ mA} \text{ cm}^{-2}$ , as shown in Fig. 4. The cell voltage is the potential difference between the anode and cathode potentials. Consequently, the dramatic variations of cell voltage in Fig. 2 is mainly attributed to the change of the anode and cathode overpotentials. But the cell performance can be almost completely recovered by the treatment using 0.5 M sulfuric acid solution. Accordingly, it can be deduced that the removable contaminants have influence on the anode and cathode reaction.

**Fig. 4.** The cathode and anode potential varying with current density from (a, d) MEA-0; (b, e) MEA-7800; (c, f) MEA-7800 Renewed.

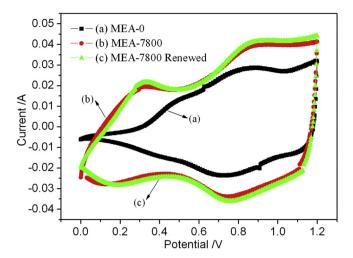
The performance of the anode catalyst was investigated using cyclic voltammograms (CV). We can see from Fig. 6, the CVs of MEA-7800 and MEA-7800 Renewed display the characteristic expansion in comparison with that of MEA-0. The increase in the total integral charge after 7800 h is ascribed to the gradual oxidation of Ir atoms available in the catalyst layer, which leads to hydration of the iridium oxide and increase of the number of active

**Fig. 6.** Cyclic voltammograms of (a) MEA-0; (b) MEA-7800 and (c) MEA-7800 Renewed.

sites accessible for the electrochemical reaction [25]. The peaks are broad and not very well depicted, suggesting an existence of variety of active surface sites with different formal potentials, which is consistent with the amorphous state of the iridium oxide [25]. In addition, a pair of broad peaks for MEA-7800 sit at the potential range of around 0.6 V-1.0 V vs. SHE. Particularly, the anodic peak of MEA-7800 localizes 0.78 V-1.1 V vs. SHE, and the peak is approximately horizontal, which is attributed to the Ir(III)/Ir(I) and Ir(V)/ Ir(VI) redox surface transition [26]. An increase of the peaks of Ir(III)/Ir(IV) and Ir(V)/Ir(VI) redox surface transition is observed after 7800 h, which may be attributed to an increase of the number of active surface sites. This also indicates that the contaminants do not cover with active surface sites in the anode catalyst layer and only occupy the ion exchange sites in the catalyst layers. Moreover, the evident Pt peaks are observed at the anode, which may be attributed to the trace amount of porous titanium disc electroplated Pt draining into anode catalyst during the long-term operation.

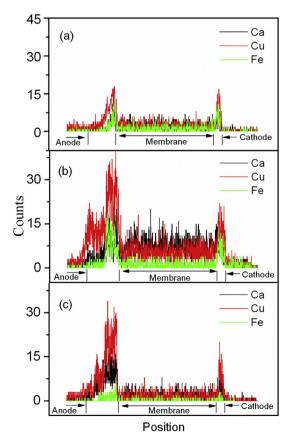
Fig. 8 shows the EPMA (electron probe microanalysis) results at the cross-section of the CCMs (the catalyst-coated membrane) from MEA-0. MEA-7800 and MEA-7800 Renewed. The distributions of Ca. Cu and Fe were analyzed. Compare to Fig. 8(a) and (c), the elements content in the membrane and anode catalyst layer shows higher relative intensity in Fig. 8(b), whereas it increases slightly in the cathode catalyst layer. This can be attributed to the low content of Nafion polymer electrolyte in the cathode catalyst layers and higher affinity of cations than protons for the sulfonic acid group sites [28–30], which also proves that metallic cations migrates from the anode to the cathode [24]. When the metallic cations gradually accumulate and approximate saturation in MEA, leading to a gradual increase of voltage at constant stack current and holds stably (see in Fig. 2). After recovery, the content of Cu and Ca almost approximates that of MEA-0, whereas Fe element shows lower relative intensity in Fig. 8(c), which indicates that the concentration of the elements content obviously decreases in the MEA-7800 Renewed after being recovered with dilute sulfuric acid. The residual cations have little influence on cell performance (see in Figs. 3,4).

Fig. 8. Distribution of cations impurities in the cross-section of (a) MEA-0; (b) MEA-7800 and (c) MEA-7800 Renewed.

In addition, Cu and Fe still exist in other forms in the cathode catalyst layer. Cu<sup>2+</sup> has quite positive Nernst potential and can be easily reduced to Cu at the cathode, which could cover with catalyst and block the active sites of platinum [31]. Moreover, Nernst potentials of  $Fe^{3+}$  is -0.01 V vs. SHE, so underpotential deposition (UPD) could happen at the cathode [32]. As a result, the cations impurities can occupy the cathode catalytic sites and hinder the delivery channel of protons of Nafion polymer electrolyte and membrane, which will not only increase ohmic resistance but also lead to the increase in charge transfer resistance, as given in Fig. 5.

In order to maintain the stable performance of water electrolyzer, it is important that the electrolysis stack and system's pipelines should be made of corrosion-resistant material and high purified feed water should be used. Meanwhile, it is preferable that the water quality is measured online.
